QUILEUTE TRIBAL SCHOOL

Asbestos
Location Details
November 16, 2016

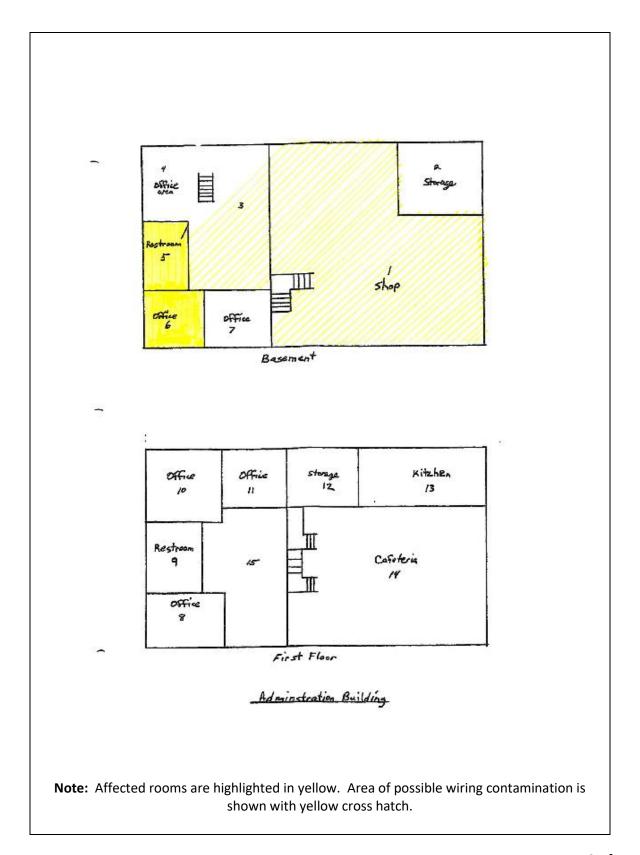
Old Administration Building (101T) - looking
East
Testing confirmed portions of building contain asbestos.

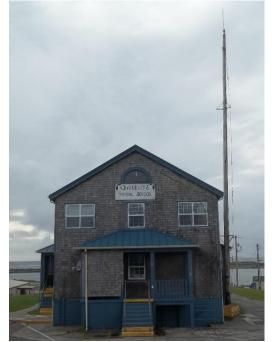
Old Administration Building (101T) – SW

[9" floor tiles and mastic of 3% Chrysotile]

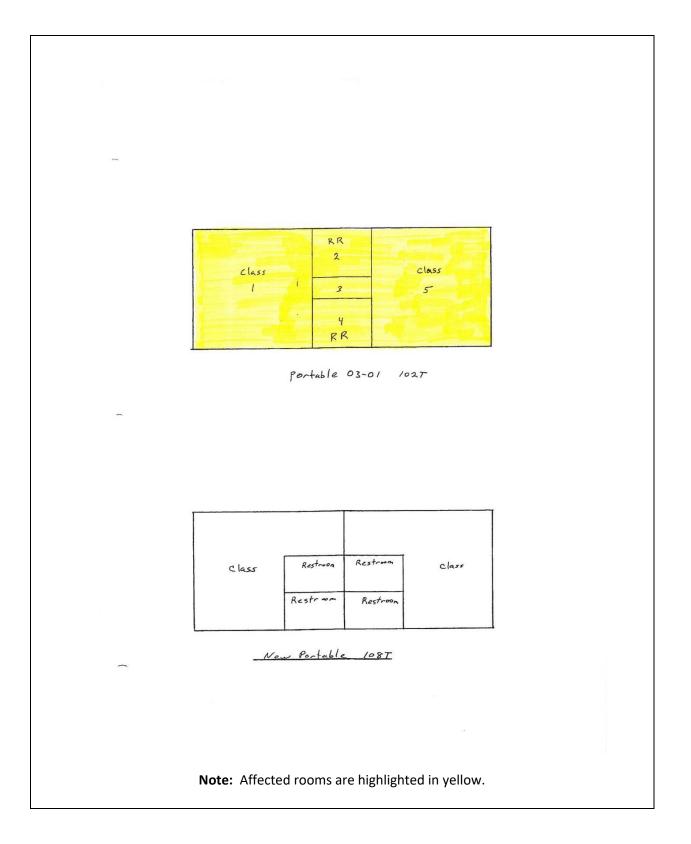
Culture Building (102T) – Picture Shows the SW Corner of the Building
