# **QUILEUTE TRIBAL SCHOOL**

**Asbestos**

**Location Details**

**February 28, 2017**

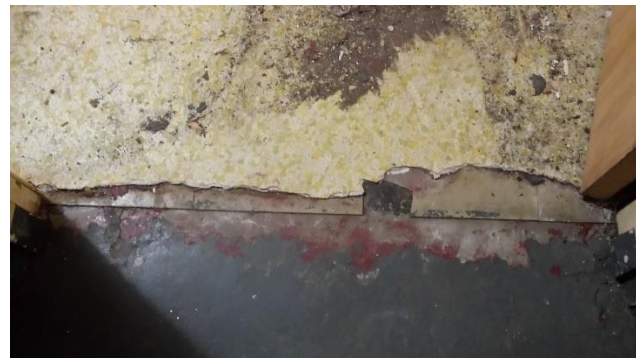
**Old Administration Building (101T) – Restroom  
5 Doorway Layer Detail**

[9" gray floor tiles and mastic of 2% and 4%  
Chrysotile, respectively. Yellow vinyl is non-  
asbestos containing per WAT 07-29-2016  
sample.]

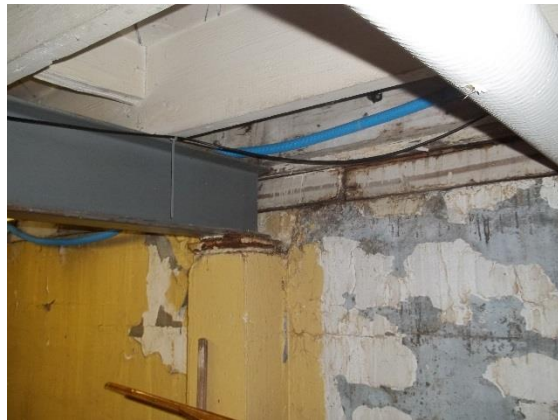
**Old Administration Building (101T) – Sample of Old Basement Office Wiring**  
[Area of possible asbestos containing material]

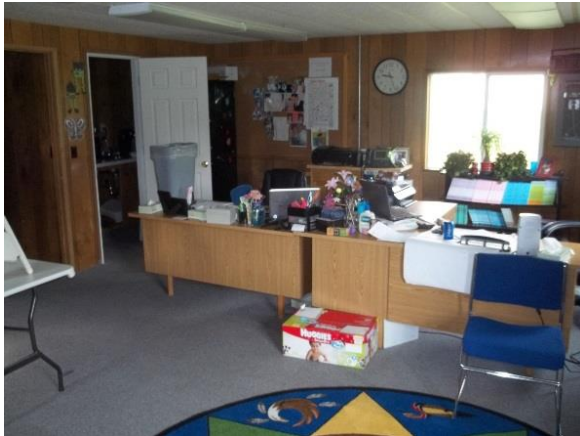
**Culture Building (102T) – Classroom 5**  
Original floor covering has been hidden by wall-to-wall carpet.  
[Sheet vinyl flooring with 30% Chrysotile]

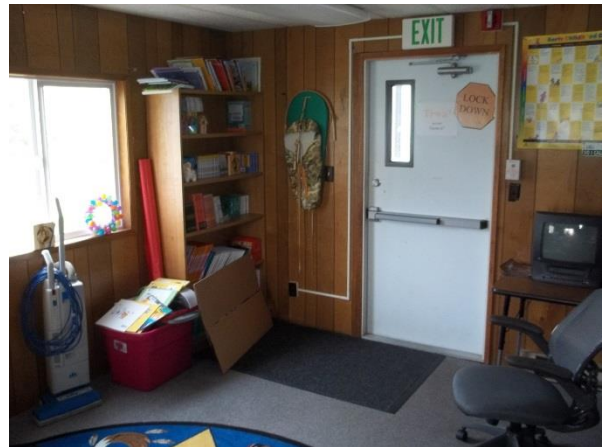
**Culture Building (102T) – NE Corner of Classroom 5**  
Original floor covering has been hidden by wall-to-wall carpet.  
[Sheet vinyl flooring with 30% Chrysotile]

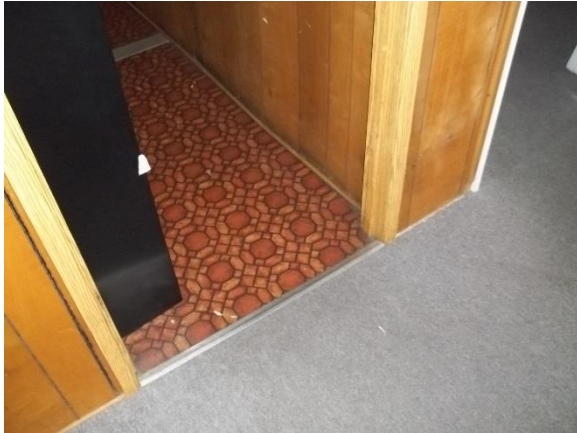
**Culture Building (102T) – Hallway to Classroom 5**

Original floor covering has been hidden by wall-to-wall carpet in classroom and hallway is original material.

[Sheet vinyl flooring with 30% Chrysotile]

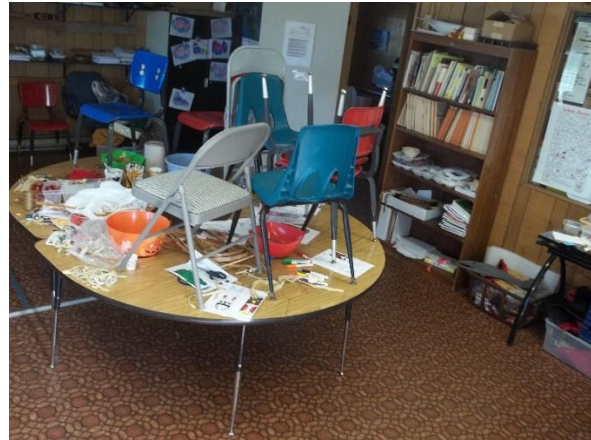
**Culture Building (102T) – NW Corner of Classroom 1**

This is original floor covering.

[Sheet vinyl flooring with 30% Chrysotile]

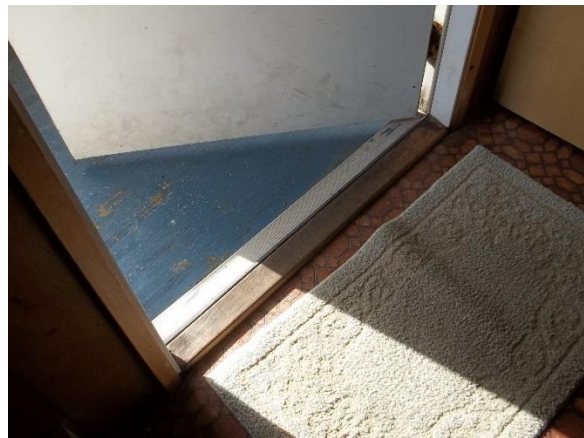
**Culture Building (102T) – Exit Doorway from Classroom 1**

This is the original floor covering covered by a throw rug.

[Sheet vinyl flooring with 30% Chrysotile]

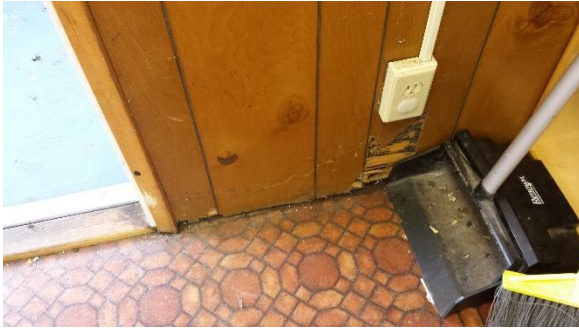
**Culture Building (102T) – SE Corner Doorway  
Detail in Classroom 1**

Original floor covering with trim removed and  
no apparent damage.

[Sheet vinyl flooring with 30% Chrysotile]

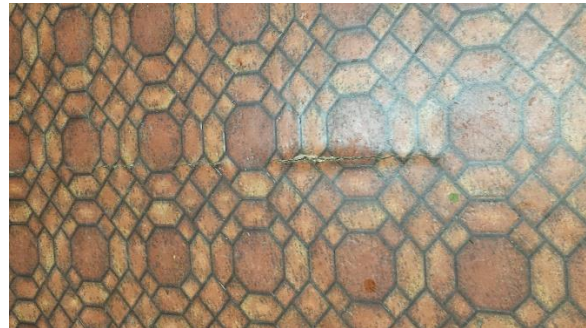
**Culture Building (102T) – Floor Covering  
Crack Detail in Classroom 1**

This is original floor covering.

[Sheet vinyl flooring with 30% Chrysotile]

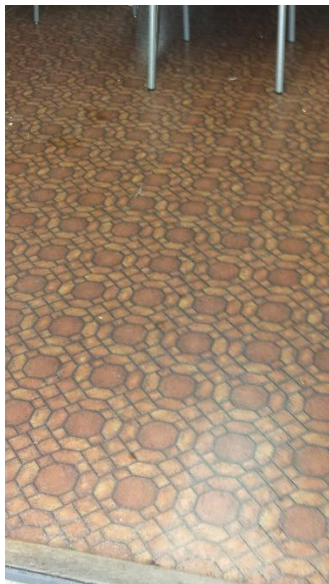
**Culture Building (102T) – Floor Covering  
General Area of Crack in Classroom 1**

This is original floor covering.

[Sheet vinyl flooring with 30% Chrysotile]

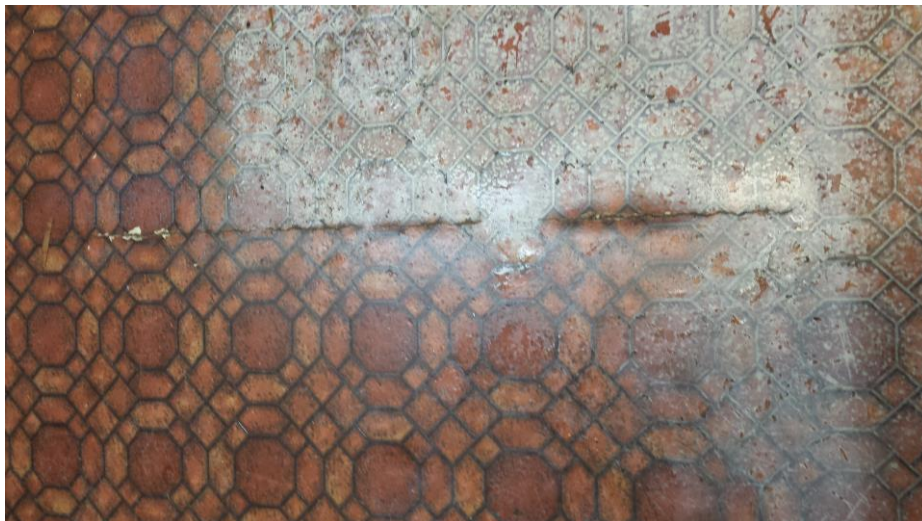
**Culture Building (102T) – Floor Covering Showing Expansion of Crack in Classroom 1**

This is original floor covering and the picture was taken on January 30, 2017.

[Sheet vinyl flooring with 30% Chrysotile]
